Accident No. 5-11-7-17

DESCRIPTION OF ACCIDENT

STATEMENT: ENGINEERING OFFICER, Regarding accident P-38J-1010, 42-67699, on 7 November 1944.

SUBJECT: P-38 (No. 42-67699) Accident of 7 November 1944, ten miles NE of Van Nuys, California.

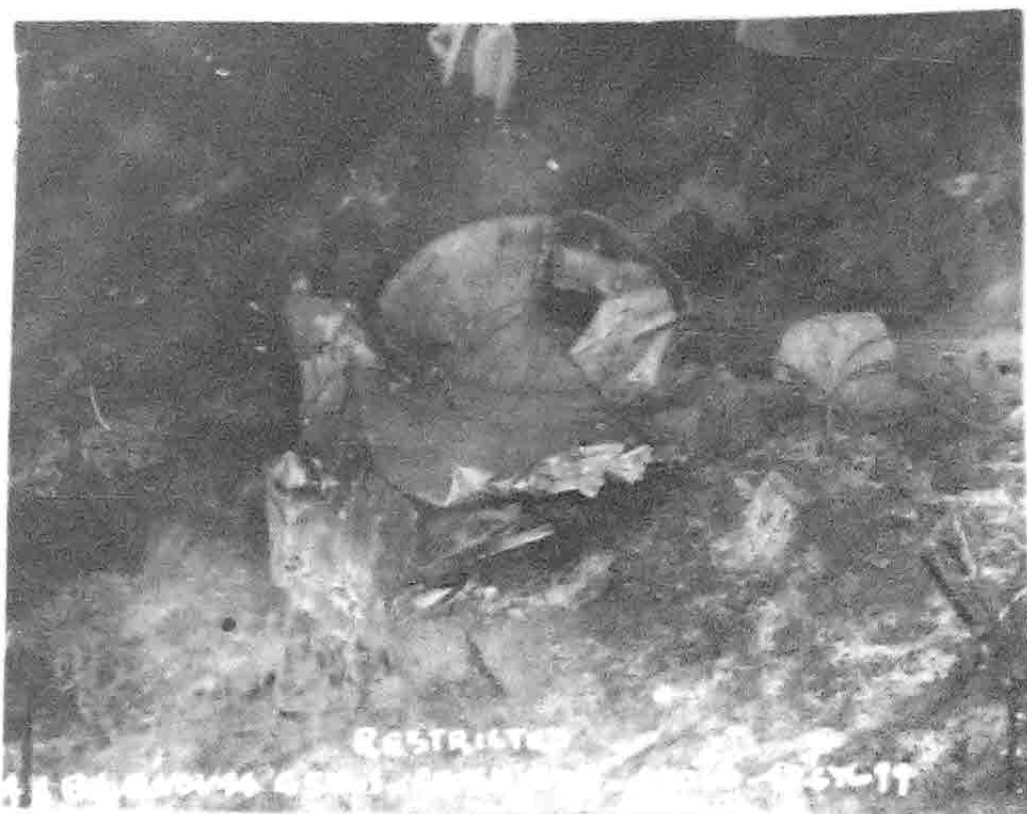
9. The crash and explosion was so violent that even the armor plate was shattered into small fragments. The only parts of the aircraft little enough damaged to be checked were the propeller hubs. Disassembly of these showed them both to be set at approximately 2790 RPM.

22. PROBABLE CAUSE: Fire of unknown origin in left engine.
23. CONTRIBUTING FACTORS: Unknown.
24. UNDERLYING CAUSE: Unknown.
25. COMMENTS: It was generally agreed by all participants in the investigation that P/O Field was unable to bail out due to possible loss of orientation in the broken clouds and haze and due to lack of sufficient altitude above the terrain. Also, fumes from the engine fire may have been a factor.
